Prosthodontic Rehabilitation of Endodontically Treated Traumatized Anterior Teeth- A Case Report

II. CASE REPORT

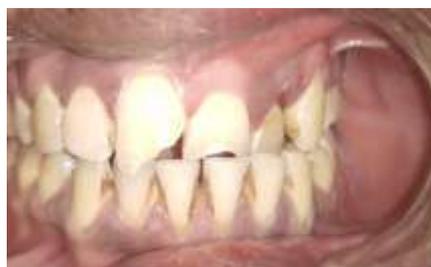
A 26yr old male male was referred to the Dept of Prosthodontics for restoration of anterior teeth i.r.t 11, 21, 22. On brief case history it was revealed that patient had meet with an accident and had traumatized anterior teeth (11, 21, 22) two months before (Fig. 1), due to continuous complain of sensitivity and pain he visited the Dept of Endodontics where he underwent root canal therapy for 11, 21, 22, after which he was referred to us for crown placement.

Fig. 1. Traumatized anterior teeth.

Care evaluation showed that the crown structure was damaged till the middle third due to which conventional crown placement was not possible due to lack of tooth structure for retention and resistance form. So our treatment planned included fabrication of cast metal post to enhance retention and stability. Post space preparation (Fig. 2) was done i.r.t 11, 21, 22 followed by post space impression made with self -cure acrylic later a pickup impression was made with alginate impression material along with post in the place.

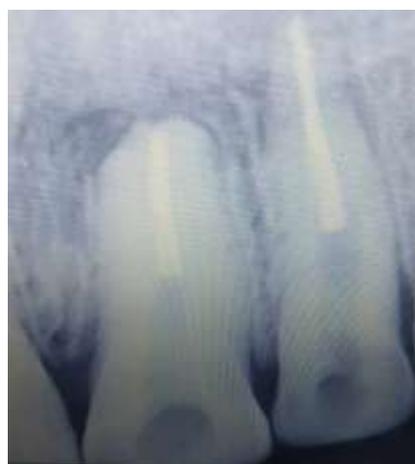
Fig. 2. Post space preparation.

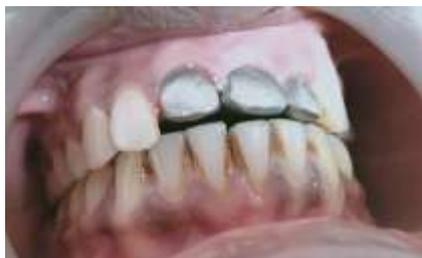
Cast was poured with die stone, wax pattern fabricated and casting prepared. It was made sure that the ferrule was given while the preparation. After finishing try-in was done to check the fit and cementation done with resin cement (Fig. 3).

Fig. 3. cementation of the custom post

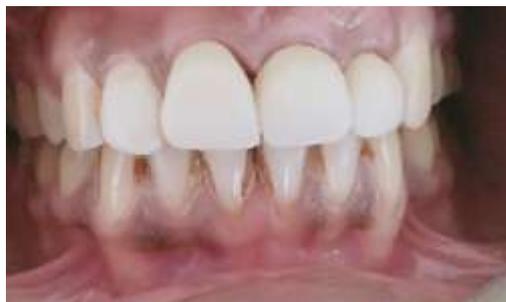
After cementation an over impression was made poured with die stone followed by shade selection for fabrication of the ceramic crown. Try-in followed by cementation the crown was done with GIC cement (Fig. 4).

Fig. 4. final crown cementation with GIC.

Post insertion instructions were given and follow was done after 1 month. Satisfactory results were obtained.
